# BEACH EROSION CONTROL REPORT ON COOPERATIVE STUDY OF CONNECTICUT

## AREAS 8 AND 11

SAUGATUCK RIVER  
TO  
BYRAM RIVER

JULY 27, 1956

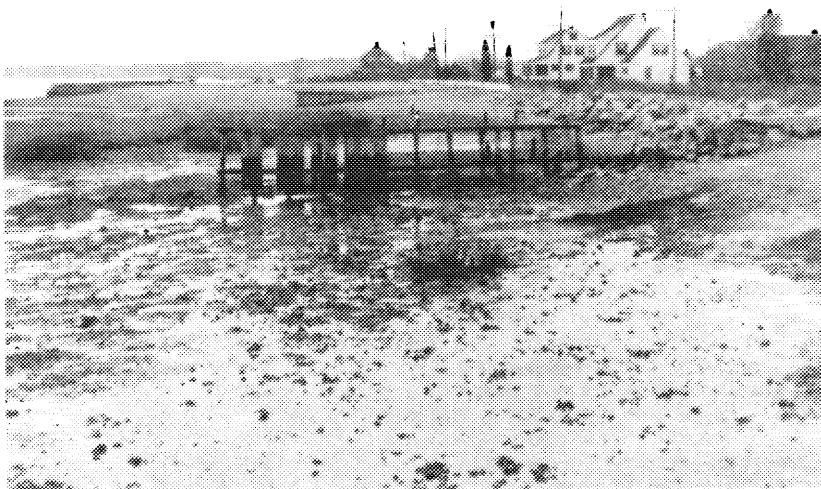
FIG. 2. SAUGATUCK SHORES, WESTPORT. Oct. 19, 1948.  
Protective structures fronting road along south shore.

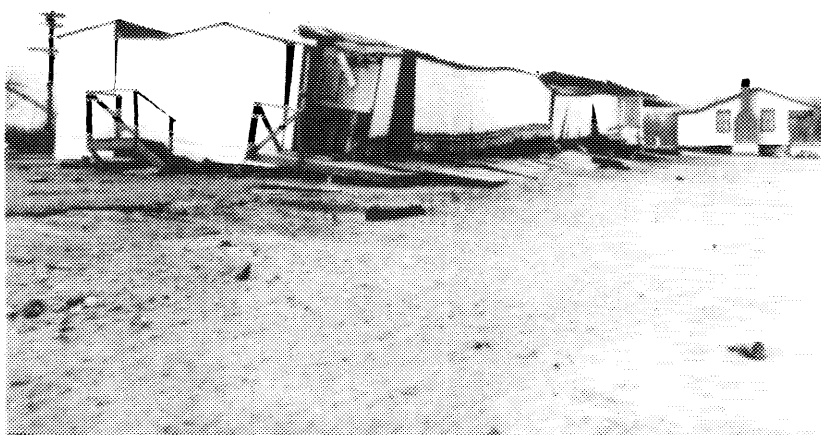
FIG. 2. CALF PASTURE BEACH PARK, NORWALK. Nov. 30, 1950.  
Bathhouse damaged by southeast storm. Compare with  
Figure 1, above.

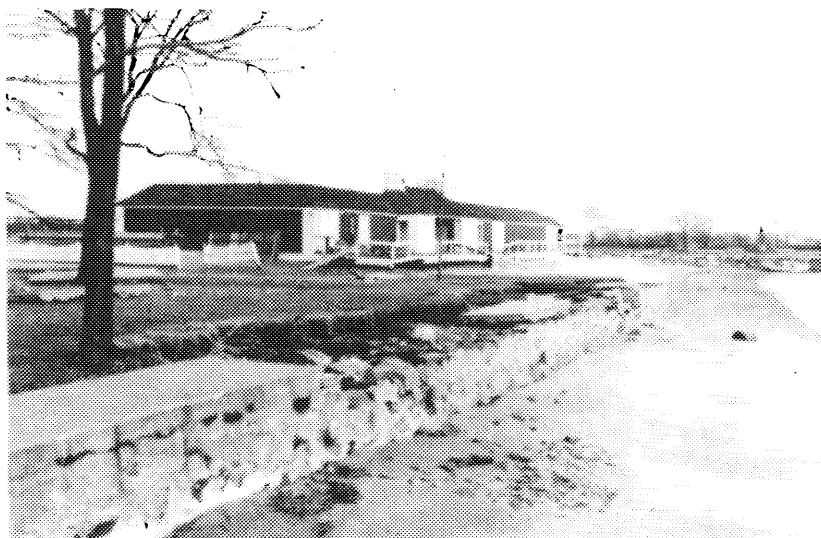
FIG. 3. GREGORY POINT, NORWALK. Nov. 30, 1950. Damage  
from severe southeast storm at private beach club.

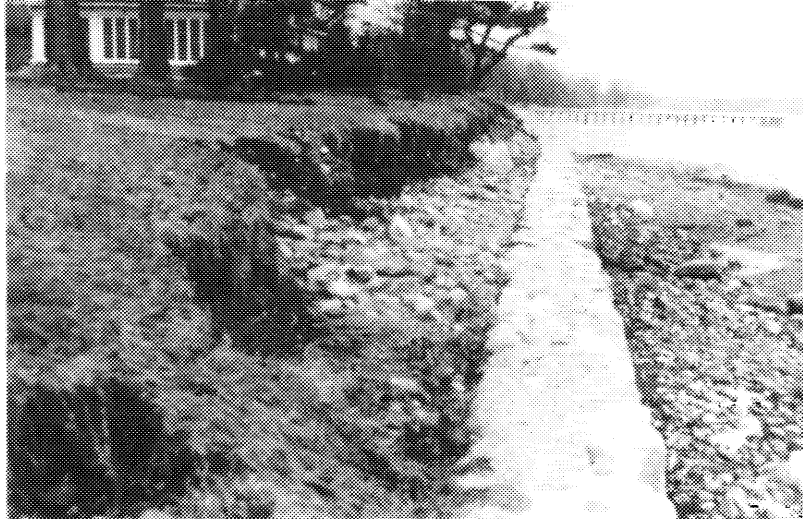
26. Long Neck Point. (Plates 17 and 28) - The shore line of Long Neck Point south of the Hay Island causeway and Peartree Point is generally at or near the foot of a continuous system of sea walls. A narrow gravelly beach fronts a part of the east shore and small accumulations of beach material are held on the south side of solid projecting structures. Elsewhere there is no beach above high water. Development consists of the Sacred Heart Academy at the outer tip of the point, large widely-spaced residences to the north generally well behind the shore and a number of piers. Along the Sacred Heart Academy property there is a riprap mound a few feet in front of the sea wall and stone paving protecting the bluff above the wall at its northeast end. Shore line changes between 1835 and 1953 were too small to permit measurement on available comparative maps. The foreshore has reportedly been lowered gradually by erosion causing undermining of sea walls. Wave attack, particularly along the east shore, has caused erosion of the bluff above the wall and has damaged walls and piers necessitating periodic maintenance. Since 1953 the riprap mound and stone slope paving of the bluff described above have been constructed at the Sacred Heart Academy. These works should provide adequate protection for the walls, and bluff against wave attack and reduce erosion of the foreshore. The use of riprap revetment in front of the toe of sea walls is a practicable and probably the most economical method of protecting them against wave attack and undermining.

FIG. 1. LONG NECK POINT, DARIEN. Dec. 19, 1953. Storm erosion along east side of Point above sea wall.

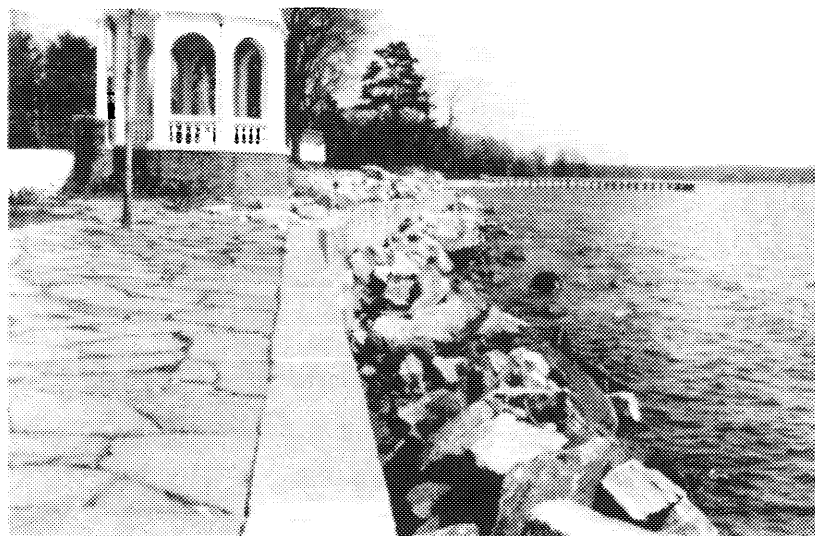
FIG. 2. LONG NECK POINT, DARIEN. Apr. 20, 1955. Recently placed riprap revetment along east side of Point. Compare with Figure 1, above.

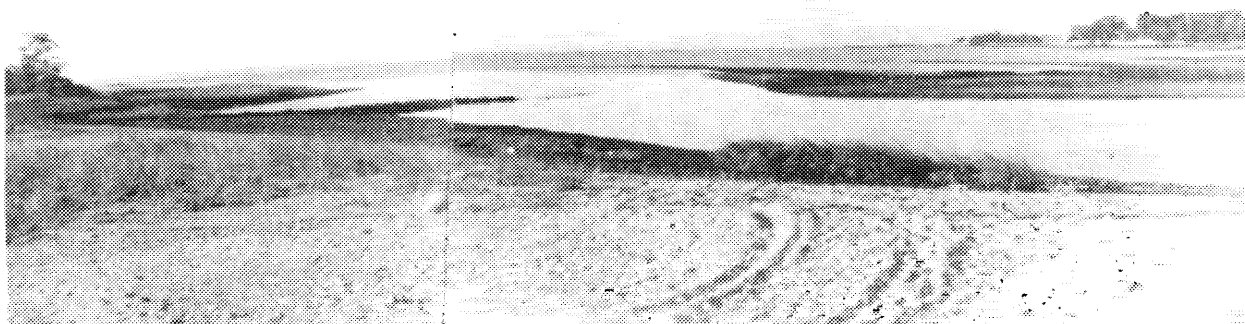
FIG. 1. WEED BEACH, DARIEN. Sept. 23, 1948. Swift tidal currents in Holly Pond entrance channel opposite Weed Beach.

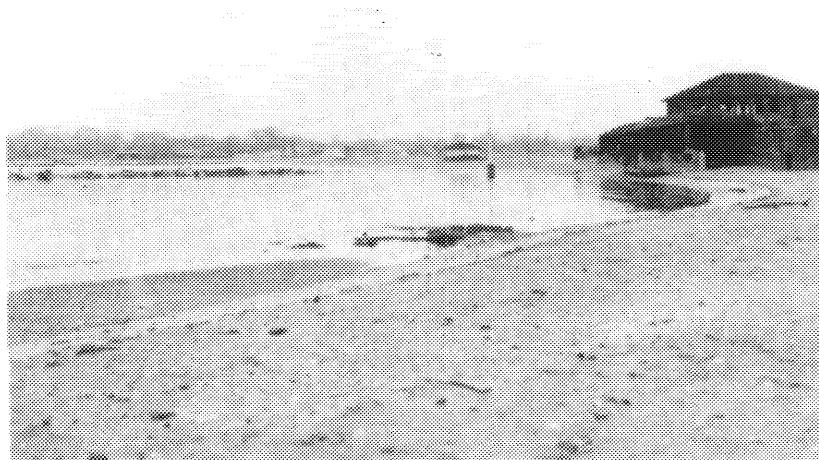
FIG. 2. CUMMINGS PARK, STAMFORD. Apr. 21, 1955. Comparison with Figure 1, above, shows shore recession. Note flanking of groin.

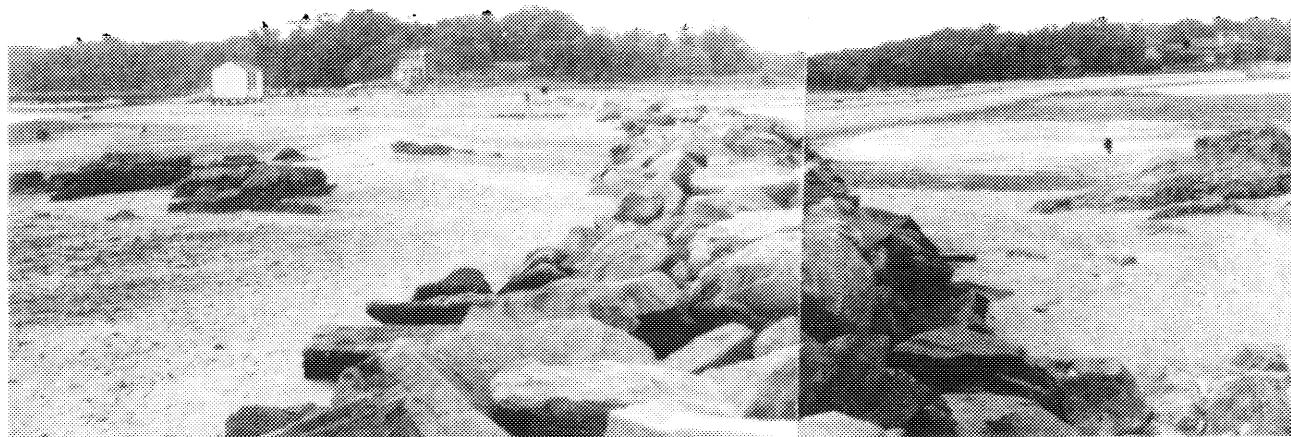
in no immediate danger from the results of erosion. Local people have reportedly requested the United States, without success, to repair and raise the jetty at Byram Point to prevent loss of beach material. It appeared from inspection of the area during 1955 that material passes around or through the structure resulting in a wide sandy deposit on the west or Byram River side of the jetty.

FIG. 3. BYRAM POINT, GREENWICH. Aug. 19, 1948. North along jetty at Byram River entrance.

A plan of protection involving landward extension and repairs to the existing jetty to make it impermeable to the passage of sand has been developed and it is shown on Plate 22A. The proposed work should reduce losses of beach material which now occur through westward drifting during the more severe easterly storms. The authorized Federal project height of the jetty of 13 feet above mean low water appears adequate for the type of protection needed. Some losses of beach material will still occur but it should be practicable to maintain an adequate bathing beach for limited private use by periodically restoring losses by placement of sand fill. Other portions of Byram Shore are adequately protected by existing sea walls or need no protection due to their rocky composition.

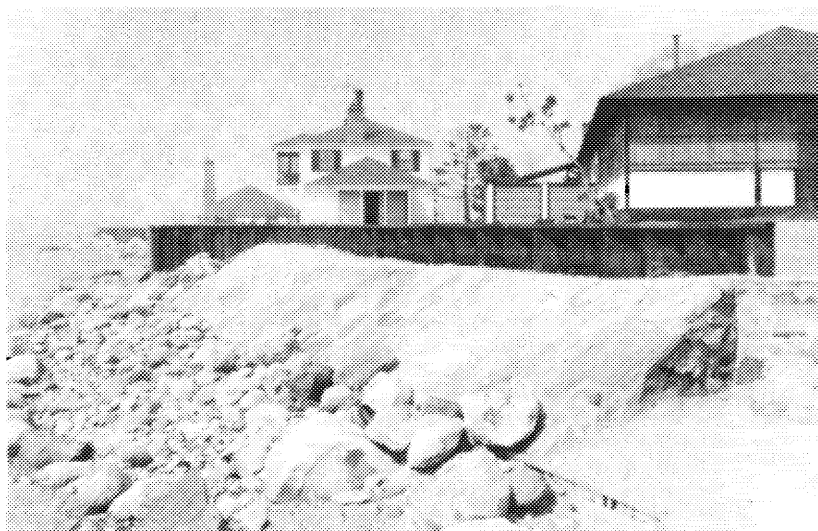
**FIG. 3. LITTLE CAPTAIN ISLAND, GREENWICH. May 4, 1955.**  
New steel bulkhead, sloped paving and revetment along east end of south shore.
